WIRE Mishap Investigation

Board Report

June 8, 1999

WIRE MISHAP INVESTIGATION REPORT

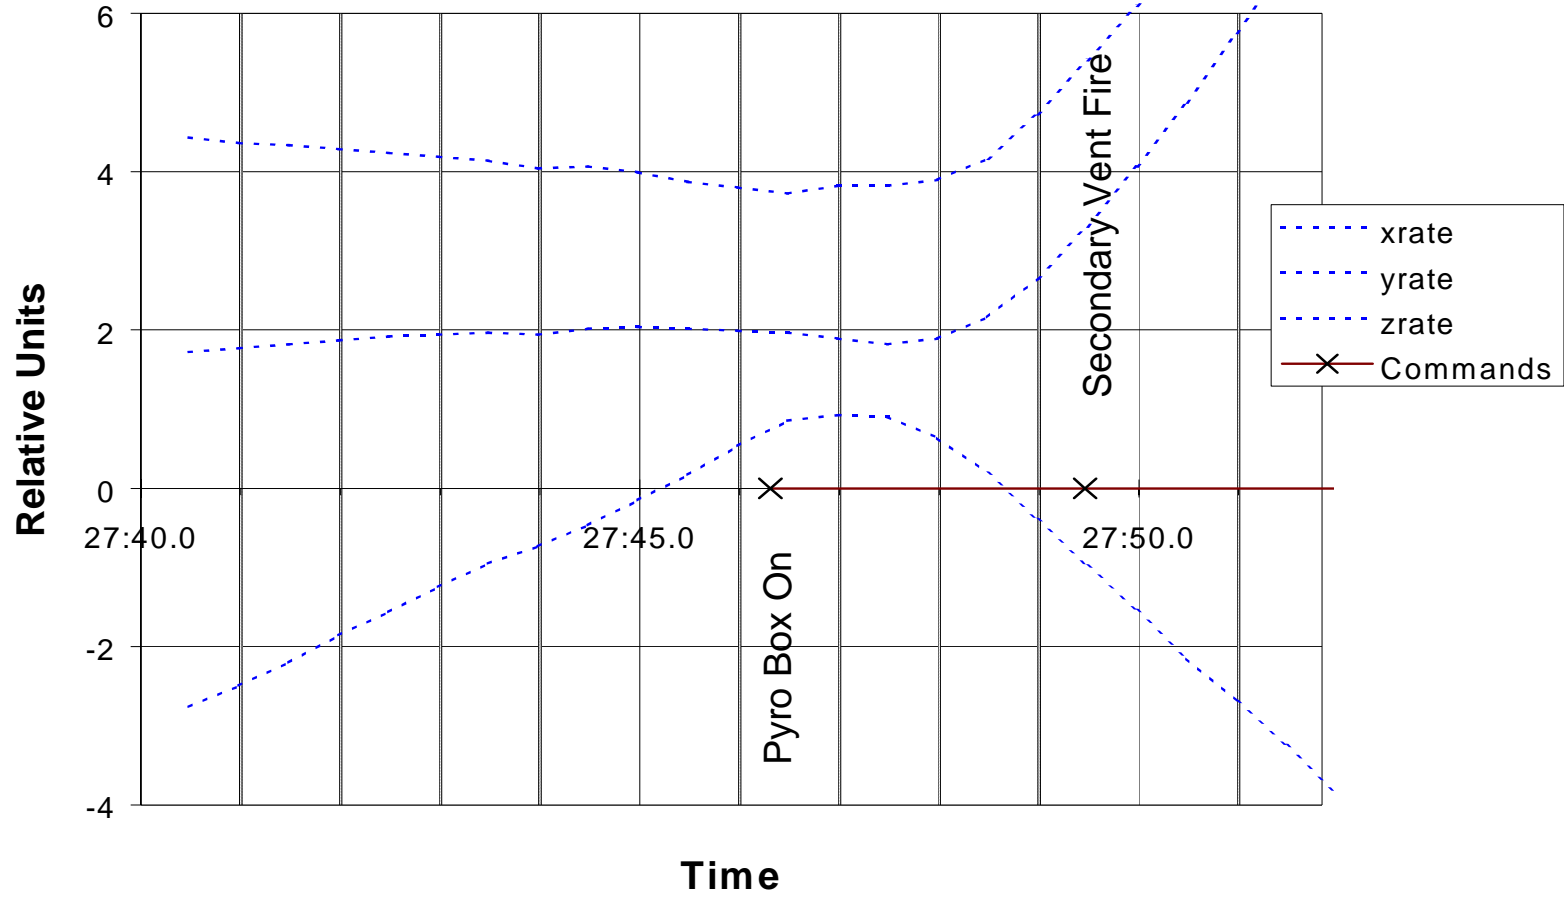
Table 2

Table 2, WIRE First Pass Telemetry, plots the spacecraft x, y, and z-axis body rate change data as a function of time. It can be seen that the WIRE spacecraft begins to move after the pyro electronics box is turned on, but before the time of the secondary vent fire command.

This data indicated to the Board that the cover could have been ejected about the time the pyro electronics box was turned on.
